NASA TN D-4881

NIMBUS II FLIGHT EVALUATION AND ENGINEERING REPORT, LAUNCH THROUGH ORBIT 5275

*Joseph J. McNaney and Bennie A. Palmer
General Electric Company*

*Ralph Shapiro
Goddard Space Flight Center*

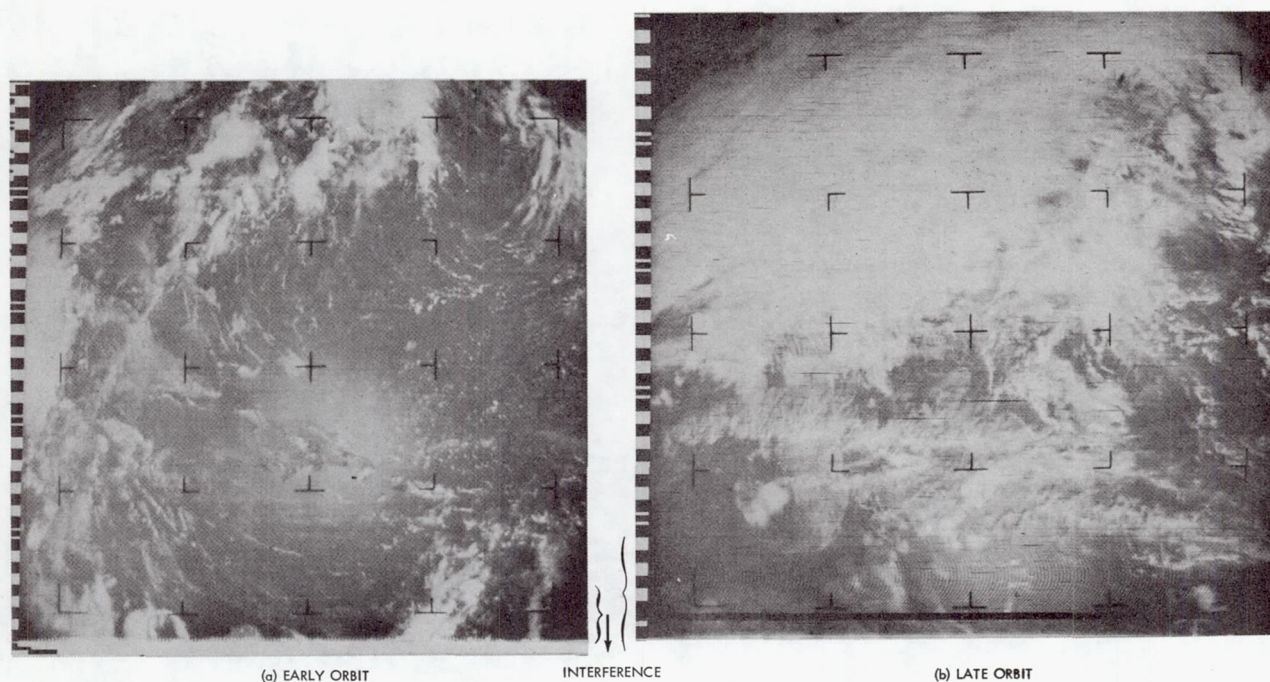
Microphonic interference from 0.7 to 0.9 kHz has occurred occasionally. The interference has increased in magnitude as the vidicon aged, affecting approximately one-eighth of the picture area during the 13 months after launch to approximately one-fifth of the picture area currently (Figure 10-6). This can be attributed to mechanical degradation of the rigidity of the vidicon internal elements. This interference should not be confused with the interference associated with the playback of the HRIR Subsystem tape recorder to be discussed below.

Figure 10-6—Comparison of APT subsystem photographs showing 0.7- to 0.9-kHz microphonic interference during early and later orbits.

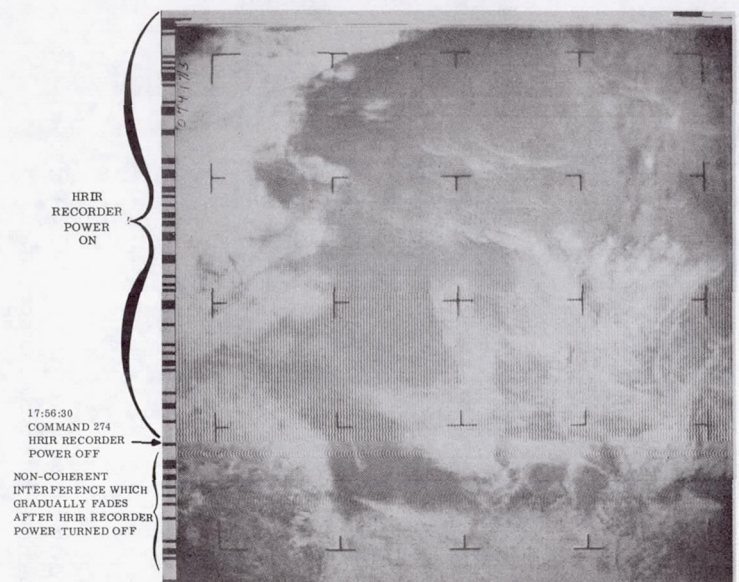
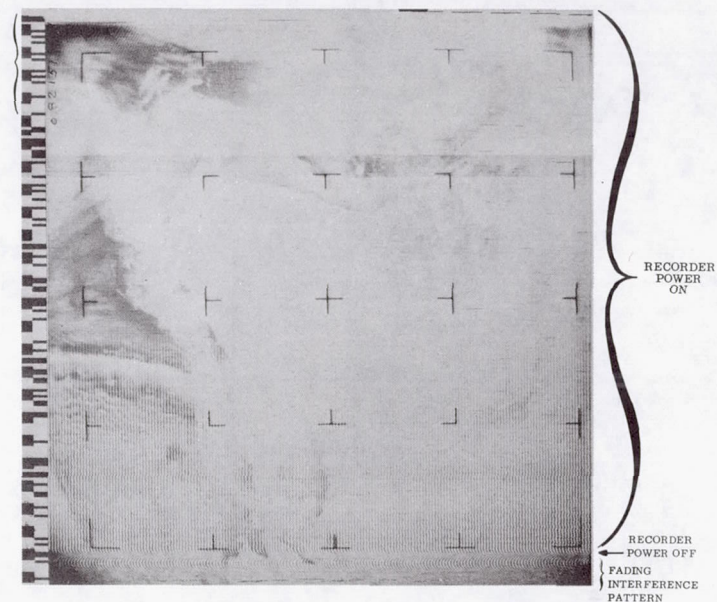
Interference has occurred occasionally when the HRIR recorder was powered in the playback mode (Figure 10-7). A similar interference occurred during prelaunch testing (Figure 10-8 and References 10 through 13). The interference varied between 0.8 kHz and 1 kHz and showed the characteristic of "fading" after removal of the HRIR recorder power. The varying frequency and the fading characteristic of this interference suggest that the interference is of a mechanical nature (vibration) induced by the operation of the HRIR recorder, which has sufficient magnitude and frequency to induce resonant vibrations of the APT vidicon internal elements during the time the APT Subsystem is reading out a picture. The APT vidicon and the HRIR recorder are mechanically mounted in close proximity on the H-frame structure of the spacecraft, and the HRIR recorder motor utilizes a 400-Hz signal as a drive source. Therefore, the interference most probably resulted from the second-order harmonic of the HRIR recorder power.

Upon removal of HRIR recorder power, the interference becomes noncoherent and fades out as the vibrations dissipate. This type of interference can seriously impede the usefulness of the APT photographs. However, since this interference is present only during that time the HRIR recorder is powered, less than 4 percent of the pictures are affected. This interference should not be confused with the microphonic interference between 0.7 and 0.9 kHz, which appears randomly at the top end of the photographs (that portion of the photograph immediately following the 300-Hz start tone and phasing portion; see Figures 10-6 and 10-7).

MICROPHONICS
INTERFERENCE
~0.9 kHz
(NOT ASSOCIATED
WITH HRIR
RECORDER ON
INTERFERENCE)

Figure 10-7—APT subsystem photographs showing fading effect of HRIR interference when power is removed from HRIR recorder.

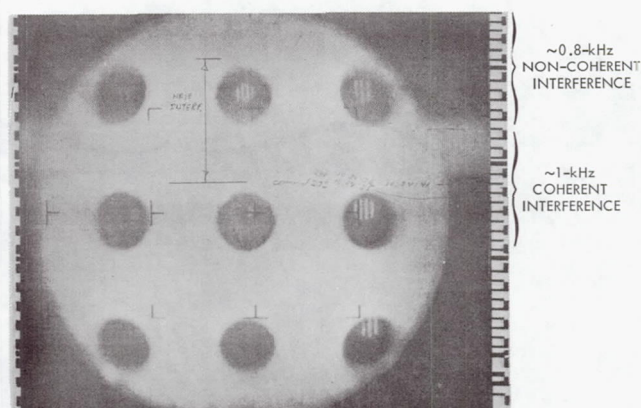
Figure 10-8— APT subsystem prelaunch photograph of target (during thermal-vacuum testing) showing HRIR interference.

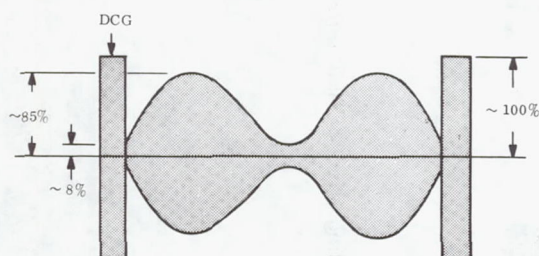
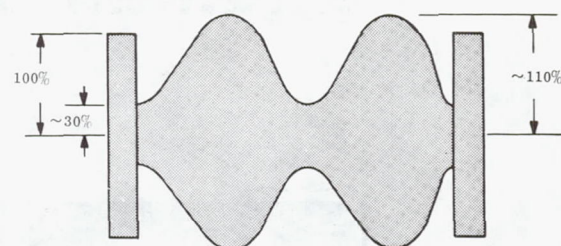
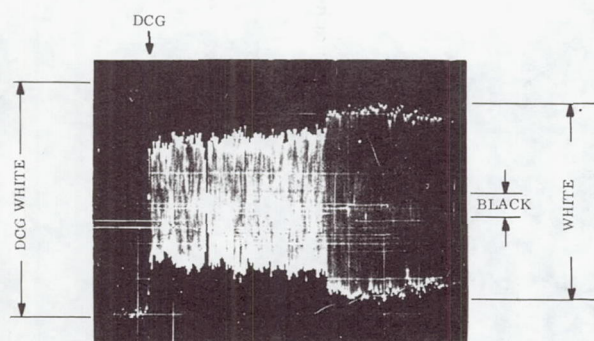
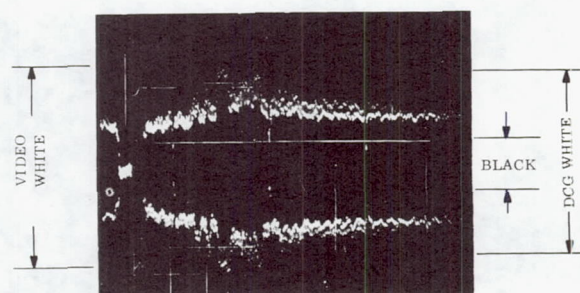
The characteristics of the APT amplitude modulation (Figure 10-9) reflect a gradual dc level shift in the video during the second 6-month period of flight. Before the level change, black-signal input drove the modulated video to approximately 8 percent of the white DCG level and, with a white input, approximately 85 percent of the white DCG level. Currently, the black modulates the video to approximately 30 percent of the dc white level, and white to approximately 110 percent of the DCG white level. Graphic presentation of this phenomenon (Figure 10-10) indicates the occurrence of a dc shift of the video toward white. Fortunately, compensation for the level change can be made within the ground station processing equipment either by

INITIAL POST-LAUNCH MODULATION LEVEL REPRESENTATION IN WHICH PEAK VIDEO WHITE LEVEL WAS $\sim 85\%$ OF WHITE DCG LEVEL AND BLACK $\sim 8\%$ OF WHITE DCG LEVEL.

CURRENT MODULATION LEVEL REPRESENTATION IN WHICH PEAK VIDEO WHITE LEVEL IS $\sim 110\%$ OF WHITE DCG LEVEL AND BLACK $\sim 30\%$ OF WHITE DCG LEVEL.

Figure 10-9—Comparison of APT subsystem video characteristics. (Oscilloscope photographs showing test-launch and late orbit characteristics.)

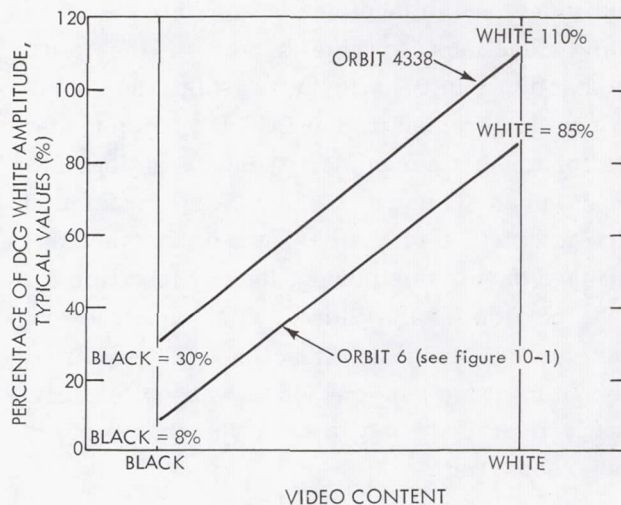
Figure 10-10-APT subsystem signal-level shift.

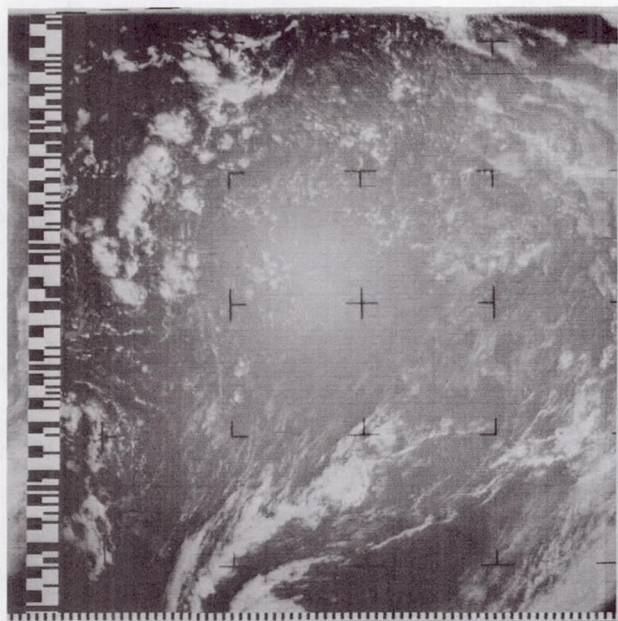
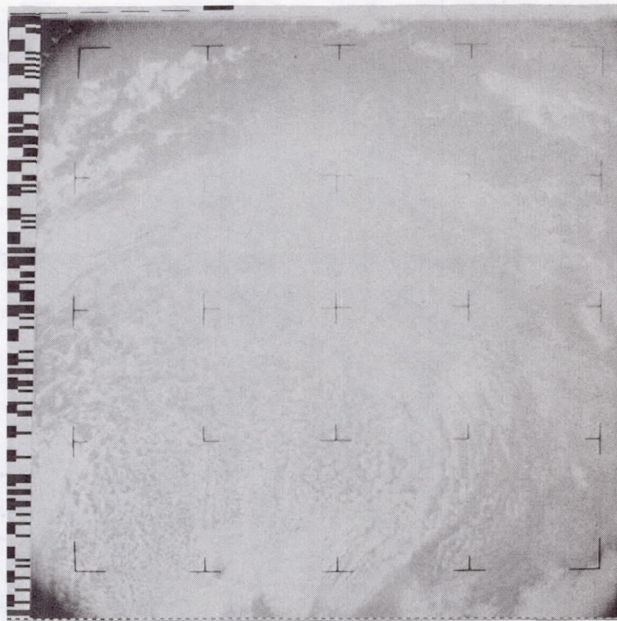
artificially inducing a negative dc bias or by altering the transfer characteristics of the ground station video processor. The following example illustrates this condition: The photographs in Figure 10-11 were received during orbits 404 and 4338. Both were processed with identical ground station transfer characteristics and signal levels. A level shift toward white is evident.

Figure 10-11-Comparison of APT subsystem photographs showing shift toward white.

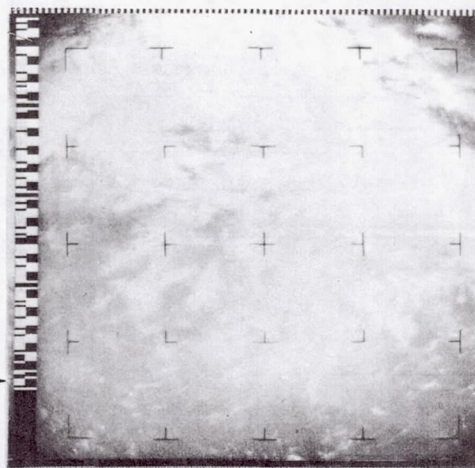
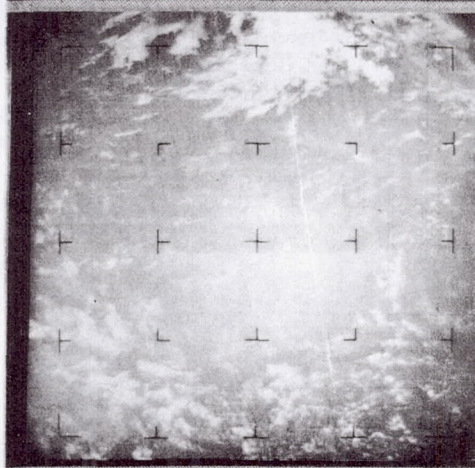
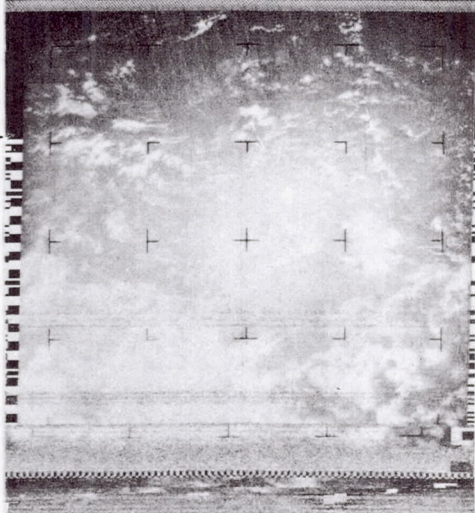
and video) establishes the dc bias for the foregoing functions for the driver of the video modulation. In an attempt to isolate the origin at the dc level shift, the DCG was commanded off for a short period during interrogation 4864 at Rosman (Figure 10-14). The modulation characteristics of the APT video remained unchanged during this period, thus eliminating the DCG portion of the video switching circuitry, the source of the malfunction. The contrast (dynamic range) of the video was not significantly degraded; only a dc level change of the video occurred.

Figure 10-14—APT subsystem photographic sequence during which data code and grid was commanded OFF/ON (interrogation 4864R).

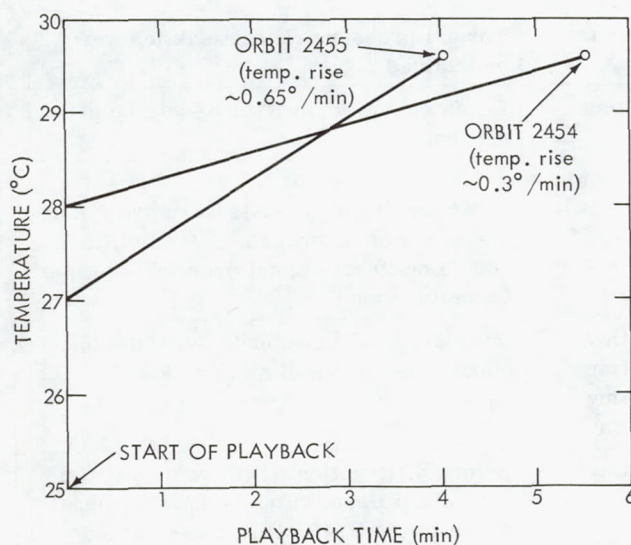
- The HRIR Subsystem, including the tape recorder, remained in the playback mode.
- Video and timing were not present at either the output of the playback amplifiers or in the composite signal input to the S-band transmitter.
- The recorder's power inverter exhibited an abnormally high temperature increase at the time of failure. This could have resulted from a higher current drain by the motor when it stalled (Figure 11-5).

Figure 11-5—Correlation of inverter temperature during normal and failure playback.

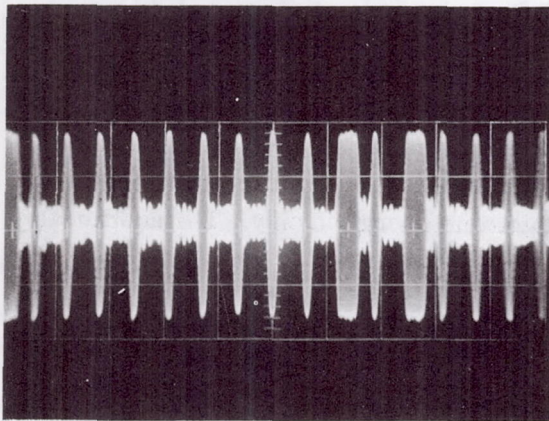
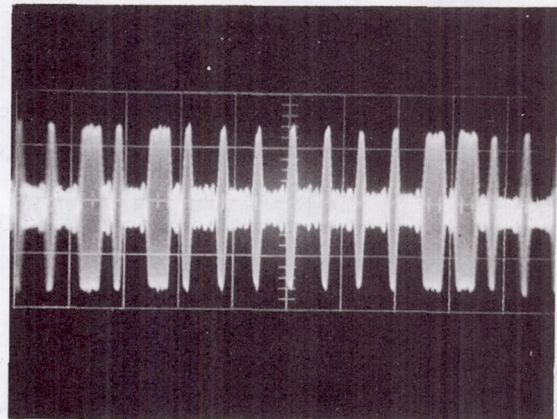
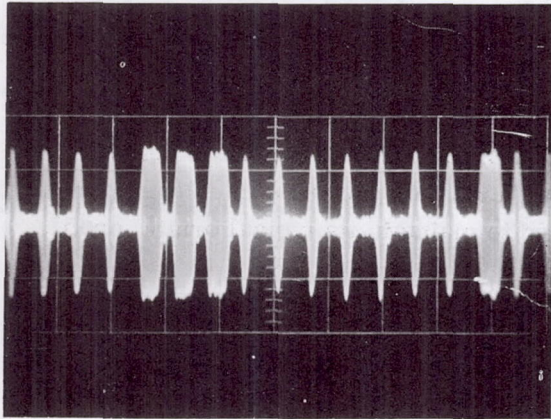
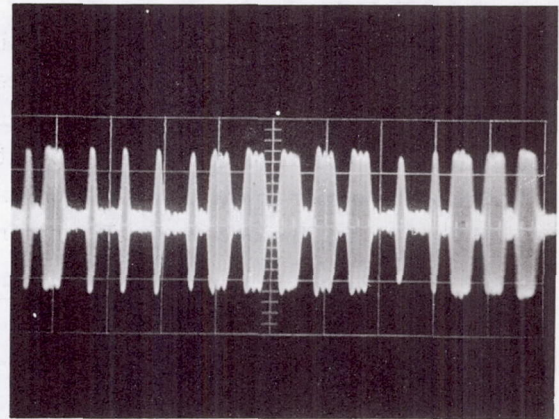
Before the failure of the subsystem recorder, clockwise* HRIR timing had consistently exhibited a 25 percent decrease in amplitude during the last 220 seconds of counter-clockwise playback and, correspondingly, during the first 220 seconds of clockwise playback (Figure 11-7). A sharp increase in recorder flutter and wow accompanied the decrease in time code. The amplitude of the counter-clockwise HRIR timing exhibited a 15 percent decrease in amplitude during this period. The length of tape affected did not increase; however, the magnitude of the degradation over the affected area slowly increased. Figure 11-8 is a typical flutter and wow strip recording showing the transition between the affected and nonaffected areas of the tape. This was probably caused by a degradation of the tape which resulted in improper tape tracking. Such degradation may have been in the form of ribboning, nonuniform stretching, or wrinkling of the tape area in question. This anomaly did not affect the quality of the stored video data.

Figure 11-7—HRIR subsystem timing amplitude degradation.

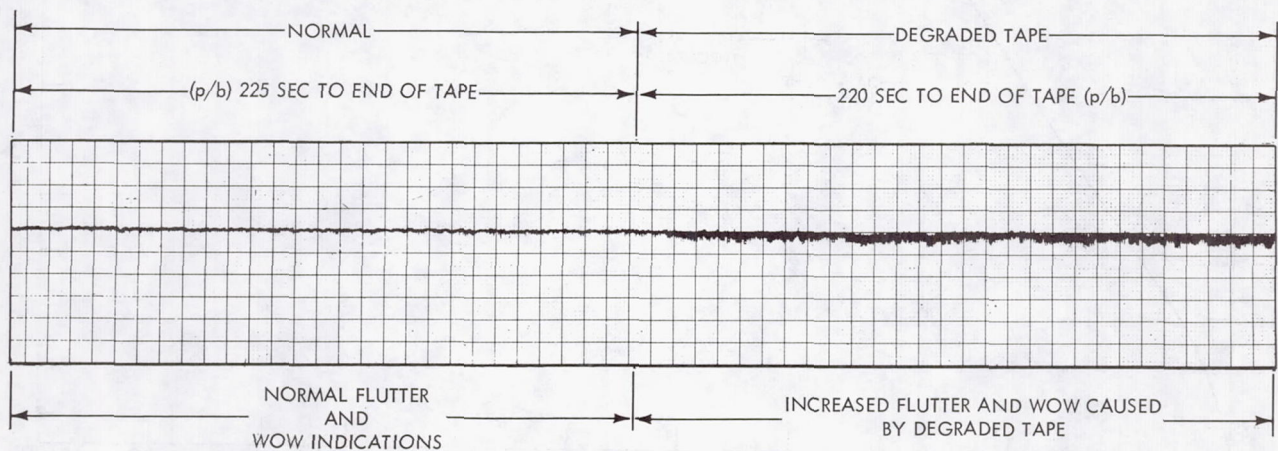
Figure 11-8—Typical flutter and wow strip recording showing transition between degraded and normal conditions.

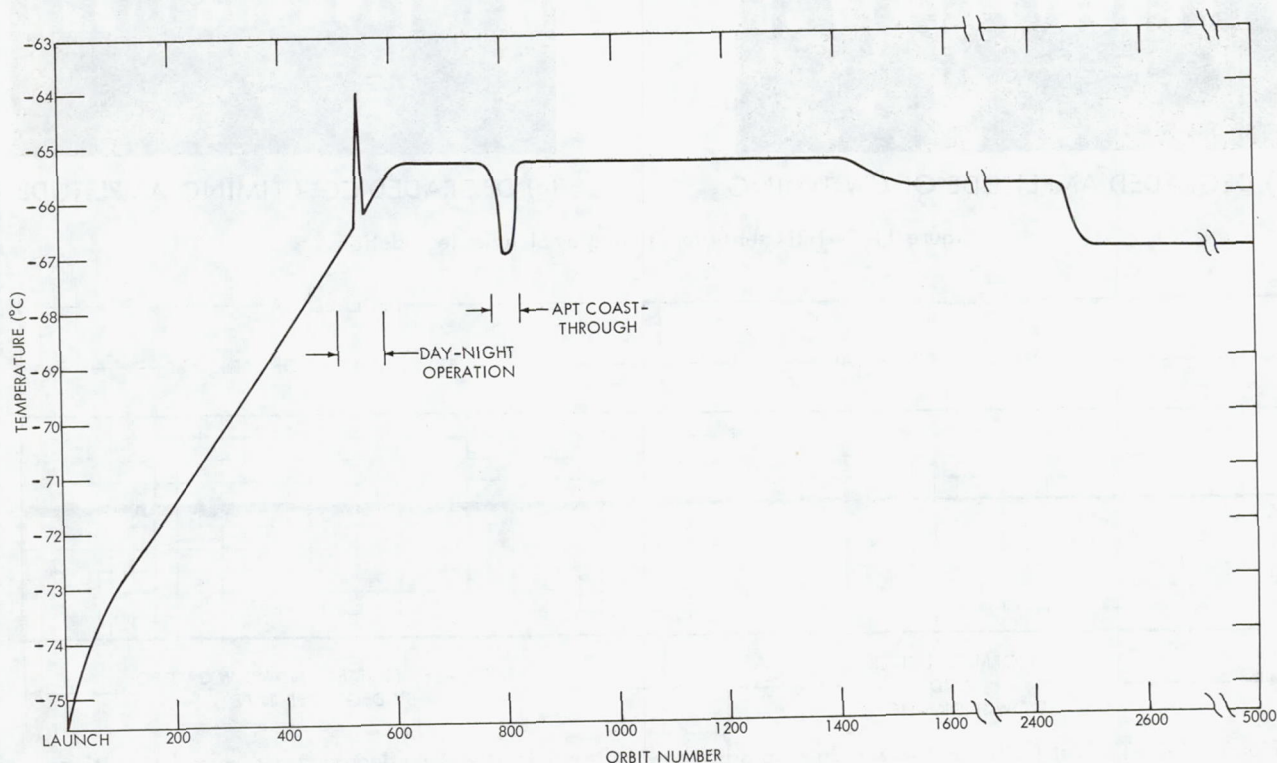
time in orbit-versus-temperature profile of the detector cell is presented in Figure 11-9. Before the failure of the subsystem recorder, the detector cell temperature orbital profile had been $-65.6 \pm 1^\circ\text{C}$, and data of excellent quality were received. After the recorder failure, a decrease of the orbital temperature profile to $-67 \pm 0.5^\circ\text{C}$ resulted since the radiometer electronics were no longer powered. Continuous day and night subsystem operation was attempted, but a general overheating of the subsystem components necessitated the return to nighttime operation only. The additional thermal loading caused detector cell temperature to increase to -64.0°C .

The elevated detector cell temperature can be attributed to distortion of the inside surface of the cooling cone at the outboard edge, flaking and/or outgassing of the black coating from the cooling patch, or improper operation of the active temperature control loop of the detector cell. Cooling cone distortion results from the high temperature produced by incident solar energy. Such distortion could not only change the cooling characteristics of the cone but could permit solar energy to be reflected to the cooling patch located at the cone apex. The flaked coating particles adhering to the cone gold surface could have changed the cone's thermal characteristics as well as those of the cooling patch itself.

of $67 \pm 0.5^\circ\text{C}$. Although laboratory tests have failed to duplicate this problem, it is presently believed that the most probable cause of the overheating of the detector cell is flaking or outgassing of the cooling patch black coating.

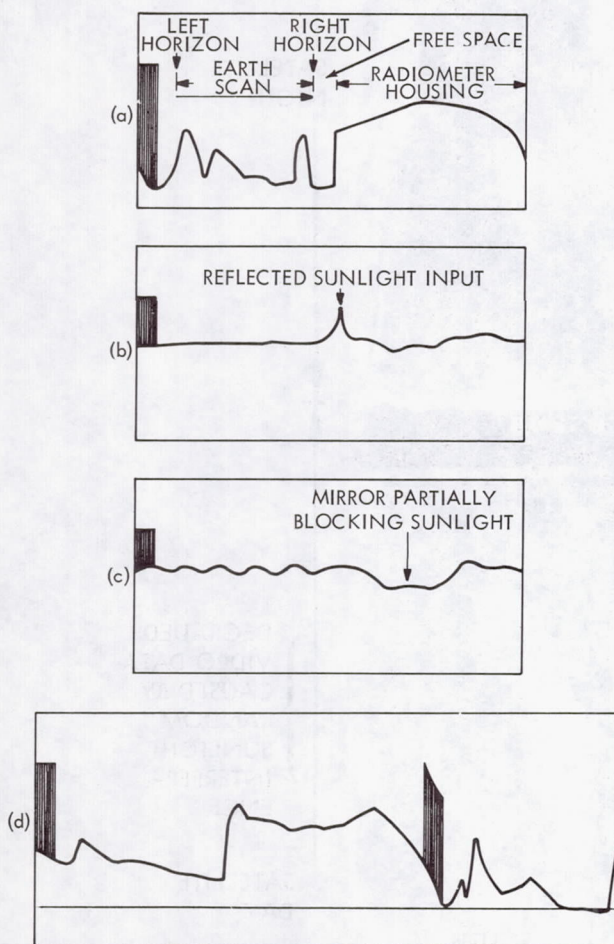
The mirror-shield portion of the Nimbus II HRIR radiometer housing (Figure 11-2) was designed to prevent incident solar radiation from entering the radiometer, assuming normal spacecraft altitudes, at a mean orbital altitude of 500 nautical miles. In the 600-nm orbit which Nimbus II attained, direct sunlight enters the detector cell at the satellite night/day transition and raises the entire video level to almost the same height as the sync pulses. Figure 11-10 shows a normal line of HRIR video (Figure 11-10a) becoming obliterated by direct sunlight entering the radiometer (Figure 11-10b). The mirror, in scanning the radiometer housing receives additional sunlight reflected from the housing. As the spacecraft proceeds, more light enters directly. The reflection

ceases, and the mirror, in scanning the radiometer housing, blocks input sunlight (Figure 11-10c). Later the radiometer housing blocks out the remaining sunlight, and the slow time constant of the bias circuit allows the signal to become slightly negative (Figure 11-10d). Sunlight obliterates all video information for approximately 1-1/2 to 2 minutes. During the period of sunlight interference, the HRIR bias circuit functions properly, slowly reducing the bias bulb voltage in proportion to video signal amplitude. Thus overall video amplitude decreases slowly. As the sunlight is blocked by the radiometer housing, the video output decreases below its pre-interference level, because of the lower bias bulb voltage (Figure 11-11). This allows the video signal to reach

Figure 11-10—HRIR sunlight interference during satellite night/day period.

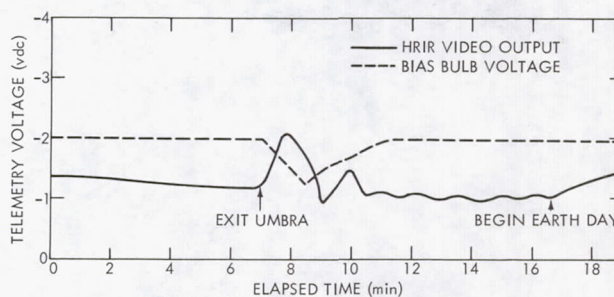
Figure 11-11—Sunlight input effects shown on HRIR telemetry.

negative levels, the condition for which the bias bulb was installed to prevent underexpected conditions. At the satellite day/night transition, sunlight is reflected from the radiometer housing into the detector cell. This is of much lower intensity than the direct sunlight at the satellite night/day transition and merely degrades video slightly for approximately 2 minutes (Figures 11-12 and 11-13).

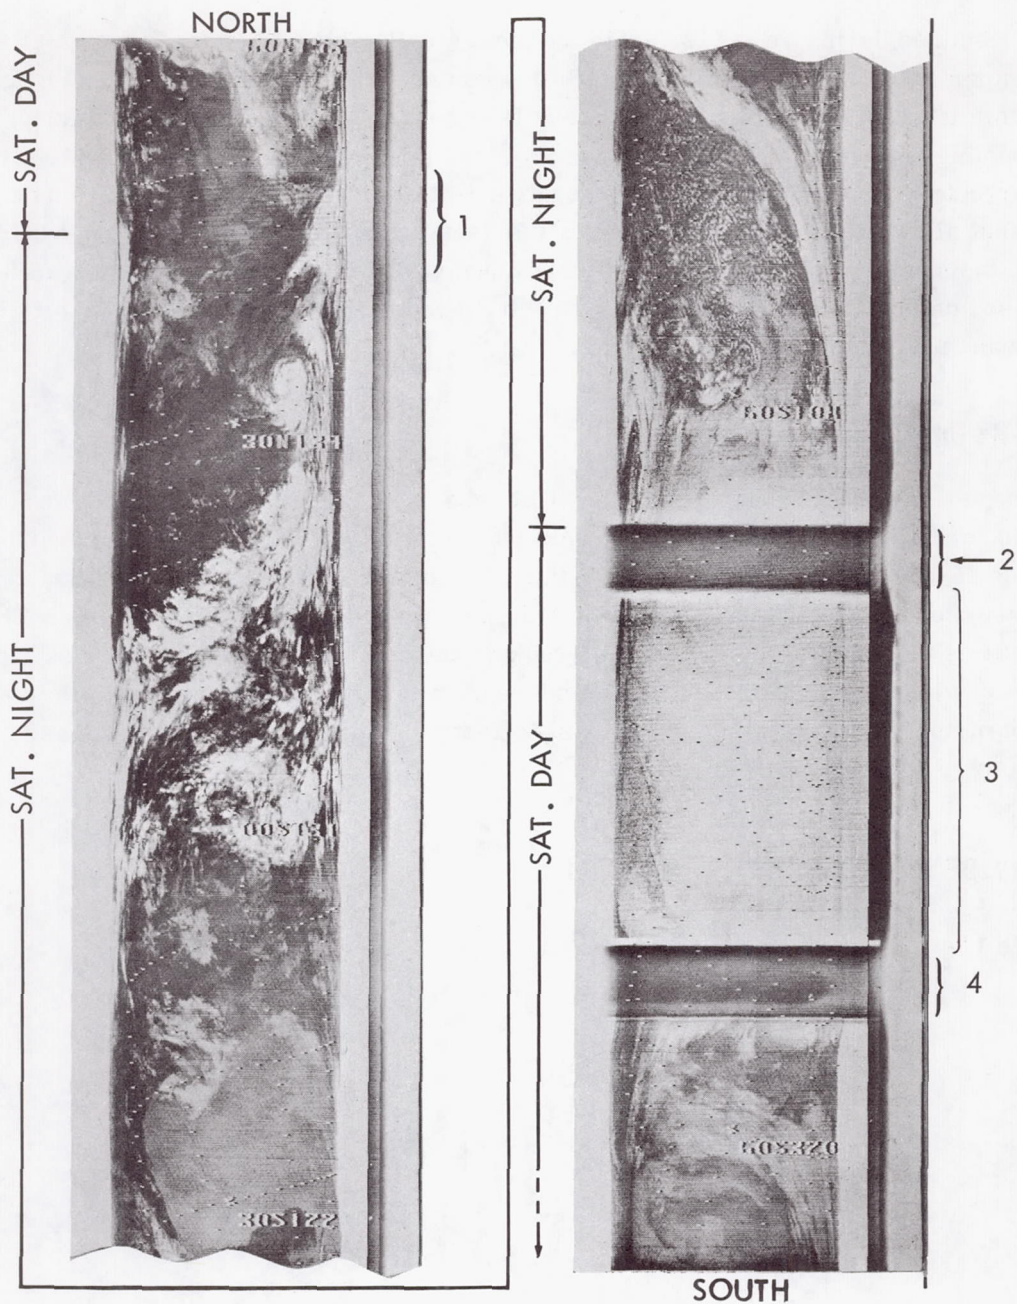
Figure 11-13—HRIR video data showing degradation caused by attitude errors
(South Pole vicinity, orbit 1122).

1. REFLECTED SUNLIGHT
INPUT AT SATELLITE
DAY-TO-NIGHT TRANSITION
2. DIRECT SUNLIGHT INPUT
AT SATELLITE
NIGHT-TO-DAY TRANSITION

3. DATA DEGRADATION RESULTING
FROM IMPROPER DETECTOR CELL
TEMPERATURE REGULATION (south
pole gridding shown)
4. DIRECT SUNLIGHT INPUT RESULTING
FROM ROLL-YAW ATTITUDE ERRORS

Data obtained during orbit 1122 exhibited a degradation similar to the direct sunlight interference experienced at the satellite night-to-day transition at this orbit position (Figure 11-13). Analysis of the video data indicated a negative 5-degree roll error spacecraft attitude. Roll/yaw cross-coupling polarity dictates that a negative yaw error will result from a negative roll error. A yaw correction, combined with a large negative roll error, had turned the HRIR detector into a position that allowed direct sunlight to enter the detector cell, resulting in degraded HRIR video data until the spacecraft had restabilized in roll and yaw. As a corrective measure, the mirror shields used on the Nimbus B radiometer have been redesigned to permit satisfactory radiometer performance at orbital altitudes of 600 nm.
